# Manhole Inspection Summary

Manhole # S07EE2007MH

**Location** Address: **2601 TANEY RD** Cross Street: **BARTOL AVE**

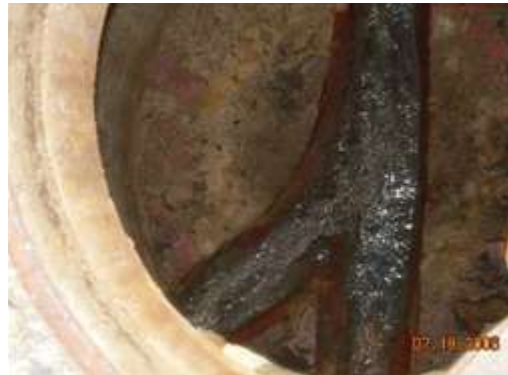
Top View

**Bench** ☒ Exists Material: **Brick** ☐ Parged ☒ **Debris** (not Condition related)  
Condition: ☒ Sound ☐ Cracked ☐ Root Intrusion ☐ Deteriorated ☐ Leaks ☐ Debris

**Steps** Count: **3** Missing: **0** ☒ **Corroded**

**Surcharge** ☒ **Evidence Of Surcharge** Depth: **1** (ft.) ☐ Active Surcharge Present

Corroded steps. Evidence of surcharge - Bench debris.

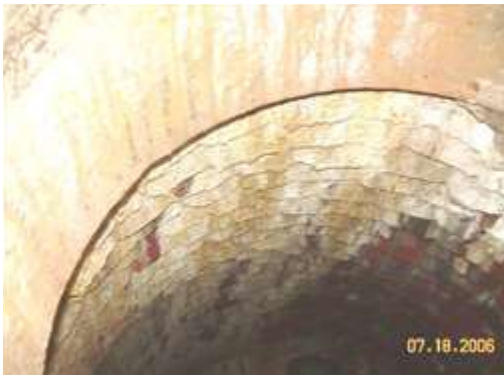
Defect

**Frame** Offset: **0** (in.) Condition: ☐ Sound ☐ Cracked ☒ **Leaks**

**Corbel** Material: **Brick** ☐ Parged Type: **Concentric/Eccentric**  
Condition: ☒ Sound ☐ Cracked ☐ Root Intrusion ☐ Loose Brick ☐ Deteriorated  
Infiltration: ☐ None ☒ **Joint** ☐ Cracks ☐ Mortar ☐ Roots ☐ Wall

**Barrel** Material: **Brick** ☐ Parged  
Shape: **Circular** Diameter: **48** (in.) Length: (in.)  
Condition: ☐ Sound ☐ Cracked ☐ Root Intrusion ☐ Loose Brick ☒ **Deteriorated**  
Infiltration: ☐ None ☐ Joint ☐ Cracks ☒ **Mortar** ☐ Roots ☒ **Wall**

Frame leaks. Corbel and Barrel infiltration.

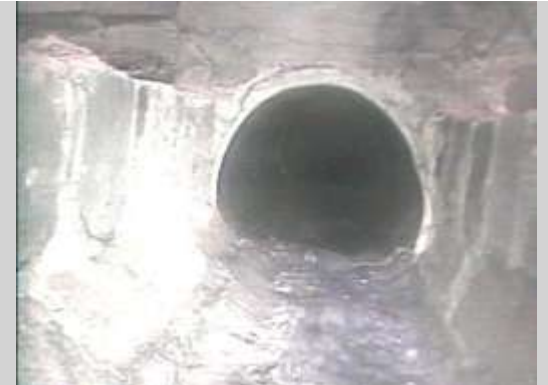
### 8 in. Circular Gravity Sewer Pipe Out @ 12 O'Clock

Barrel deterioropration and infiltration.

Infiltration: **Evidence** Pipe Seal Cond: **Cracked**

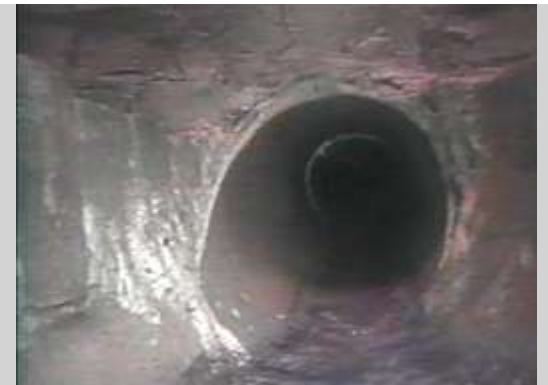
### 8 in. Circular Gravity Sewer Pipe In @ 6 O'Clock

Infiltration: **Evidence** Pipe Seal Cond: **Cracked**

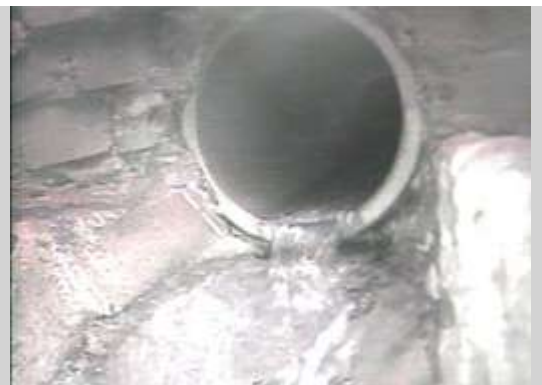
Pipe In @ 7 O'Clock

**Channel** Material: **Brick** ☐ Parged ☐ Debris (not Condition related)  
Channel Exposure: **Fully Open** Junc Dist: **0** nearest .5 ft. Azimuth:  
Condition: ☐ Sound ☐ Cracked ☐ Root Intrusion ☒ **Deteriorated** ☐ Leaks ☐ Debris

Channel deterioration.

Pipe Seal Cond: **Cracked**
